Mid West Region

**Cloverdale
Farm**

**A Conventional
Subdivision**

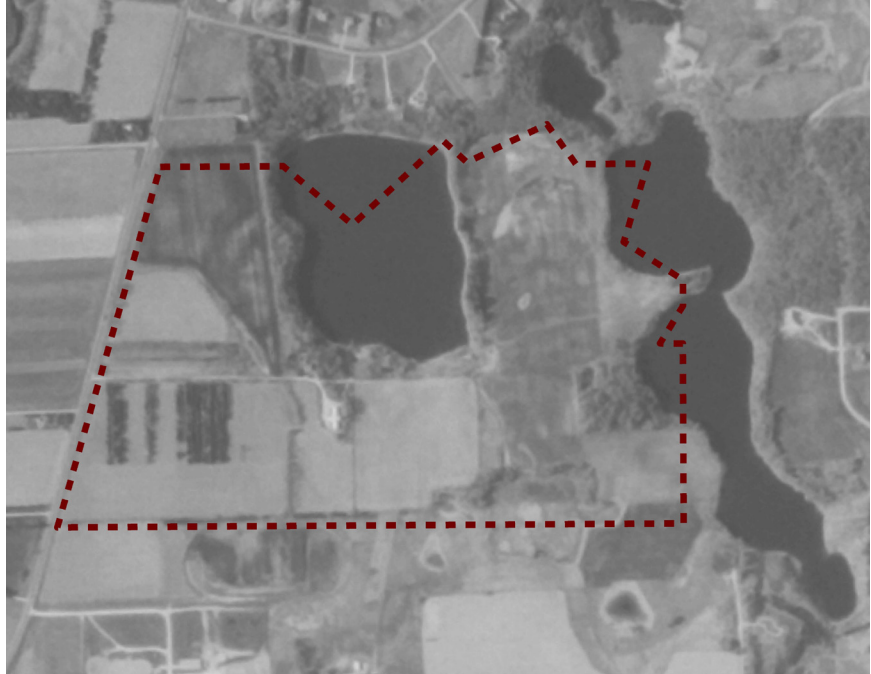
Figure 1: The site in 1992 before development. Agricultural land use predominates, with forest stands surrounding the central pond, and a parcel of forest in the eastern portion of the site.

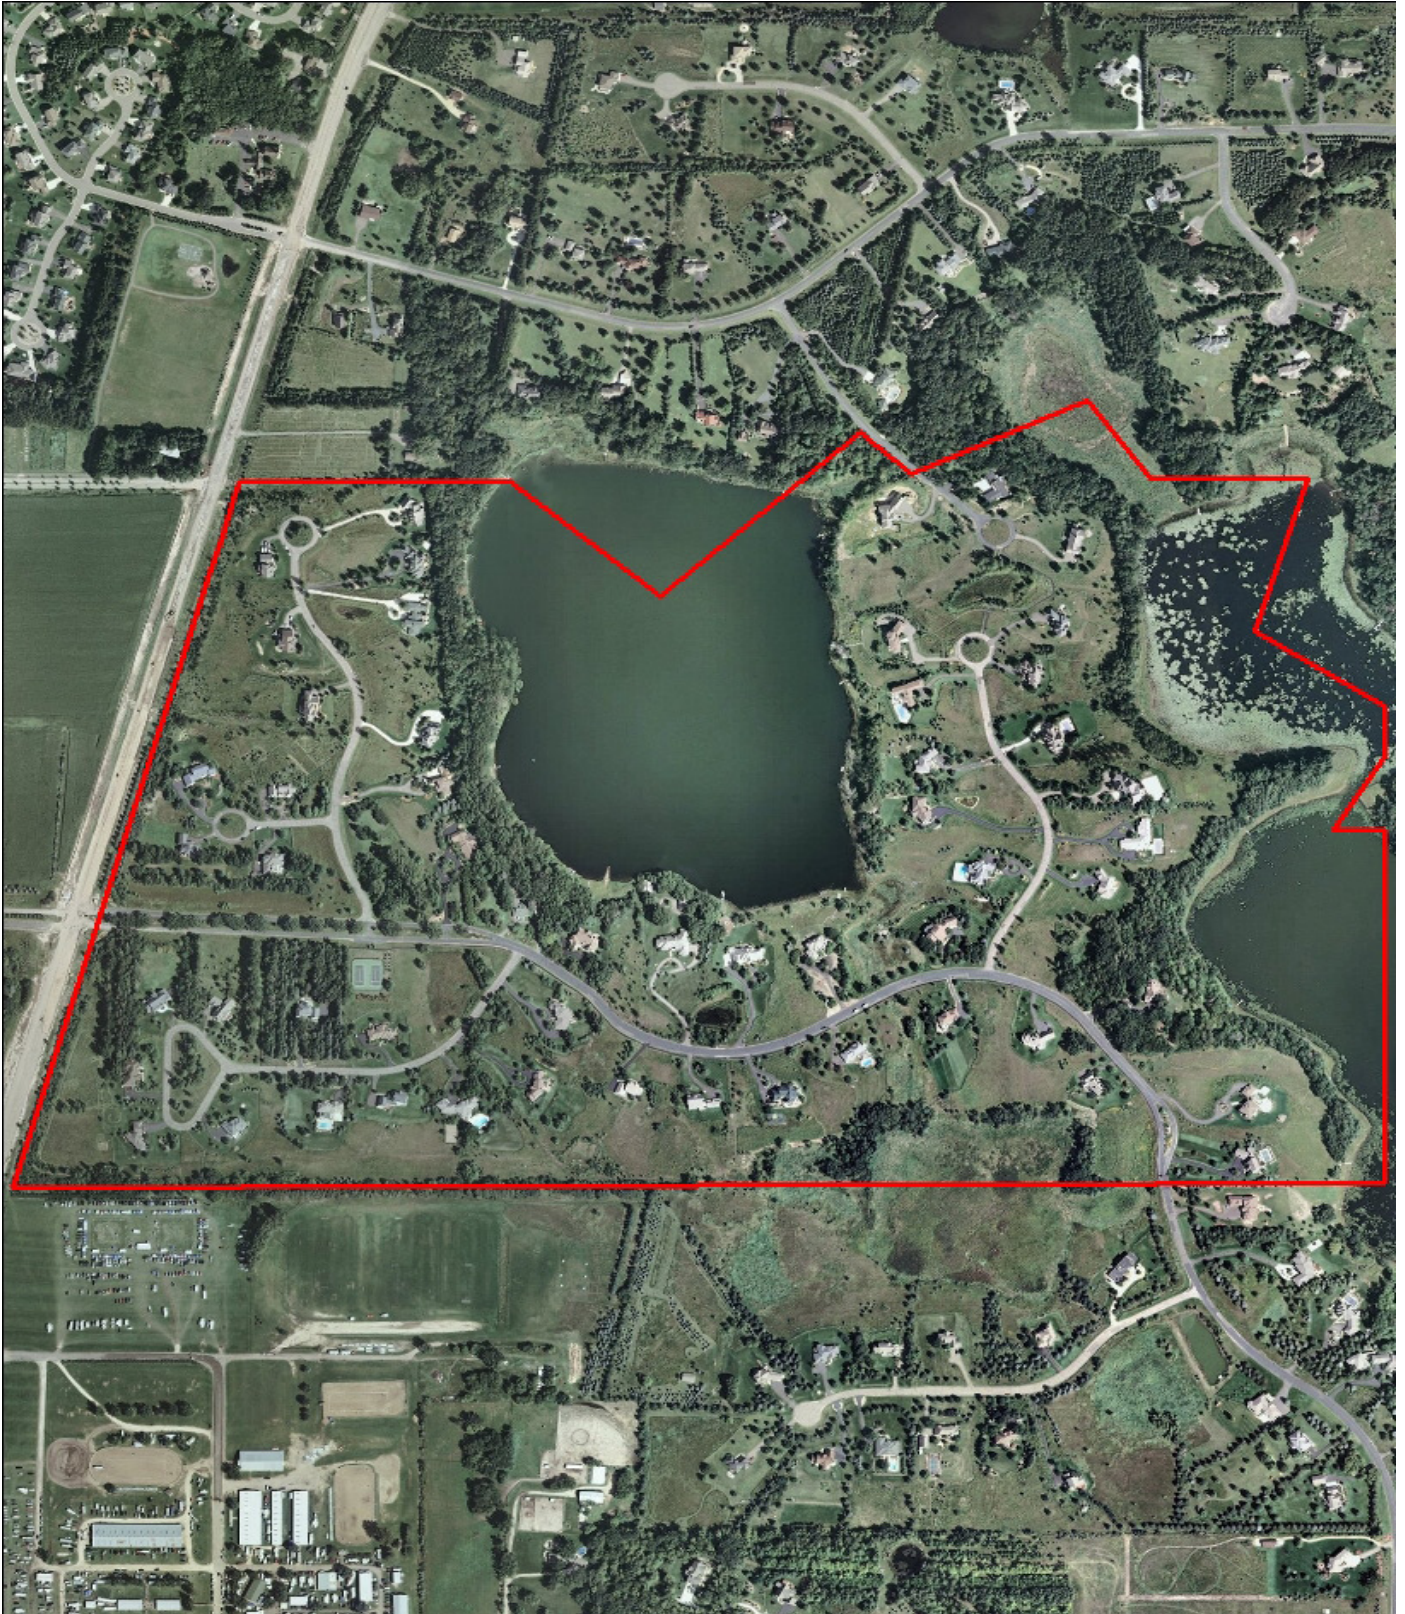
Figure 3: The development in 2003, fully built out. Cloverdale Lake is in the center of the site, with McDonald Lake to the east.

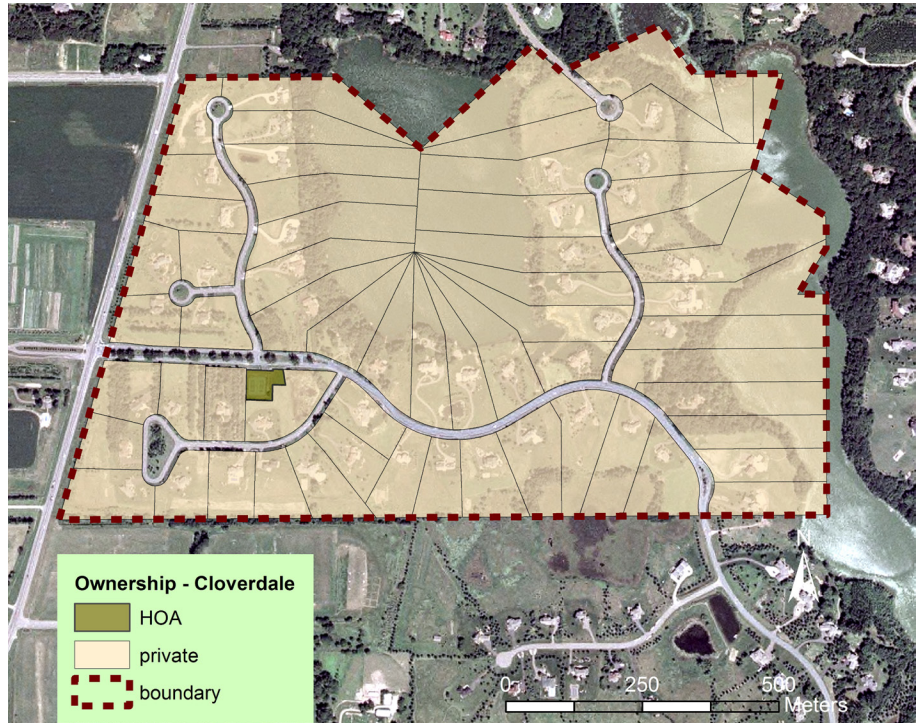
Figure 4: Site plan showing ownership of the open space in Cloverdale. Almost the entire site is held privately, with the exception of roads and a small recreation facility.

Land ownership in Cloverdale is predominantly private. Almost 93 percent of the site is privately held, with the remainder in common roads and a small parcel (0.3% of the site) held by the home owners association. Of interest is the fact that even the lakes in this development are held in private ownership.

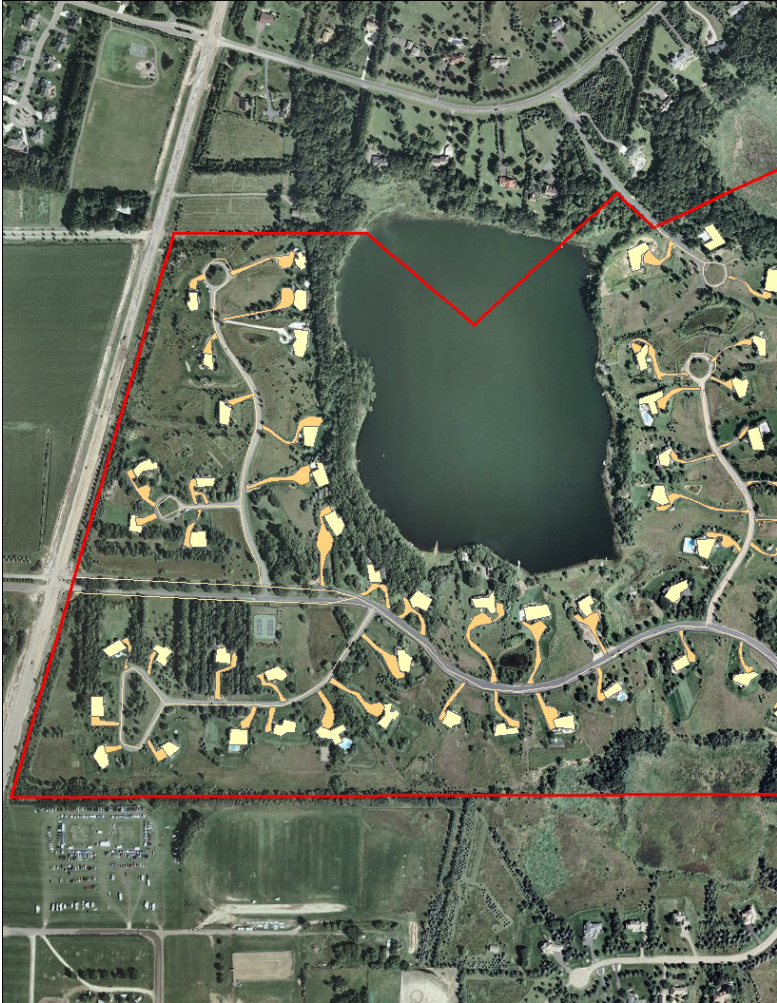
Figure 6: Impervious surface is dispersed across the development as roads, driveways and roofs.

The imperviousness of the site is relatively low at 8.8 percent. Dispersal of the imperviousness across the site allows more of the runoff to infiltrate before entering the lakes. In addition, stormwater ponds and swales were installed to augment the cleansing process.
