Kentlands

**A Neotraditional
Development**

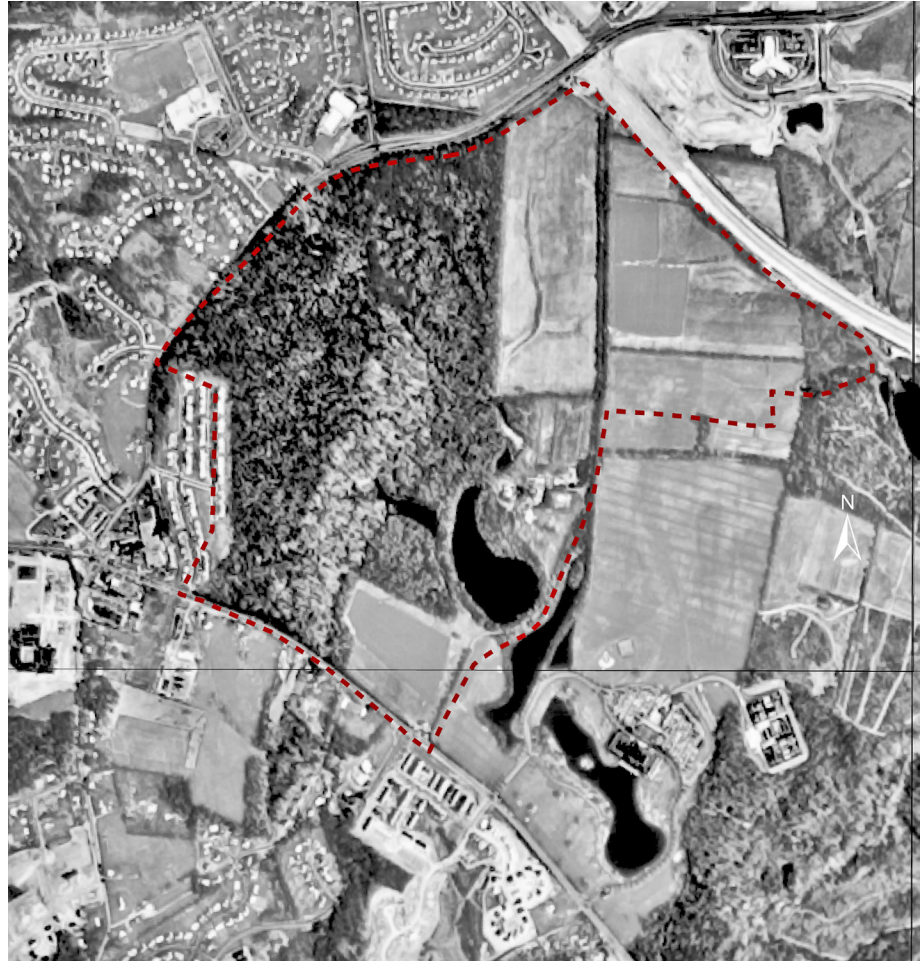
Figure 1: The site before development in 1988 is largely forested. The open, agricultural fields to the north were developed as multi-family housing and the commercial areas for the development.

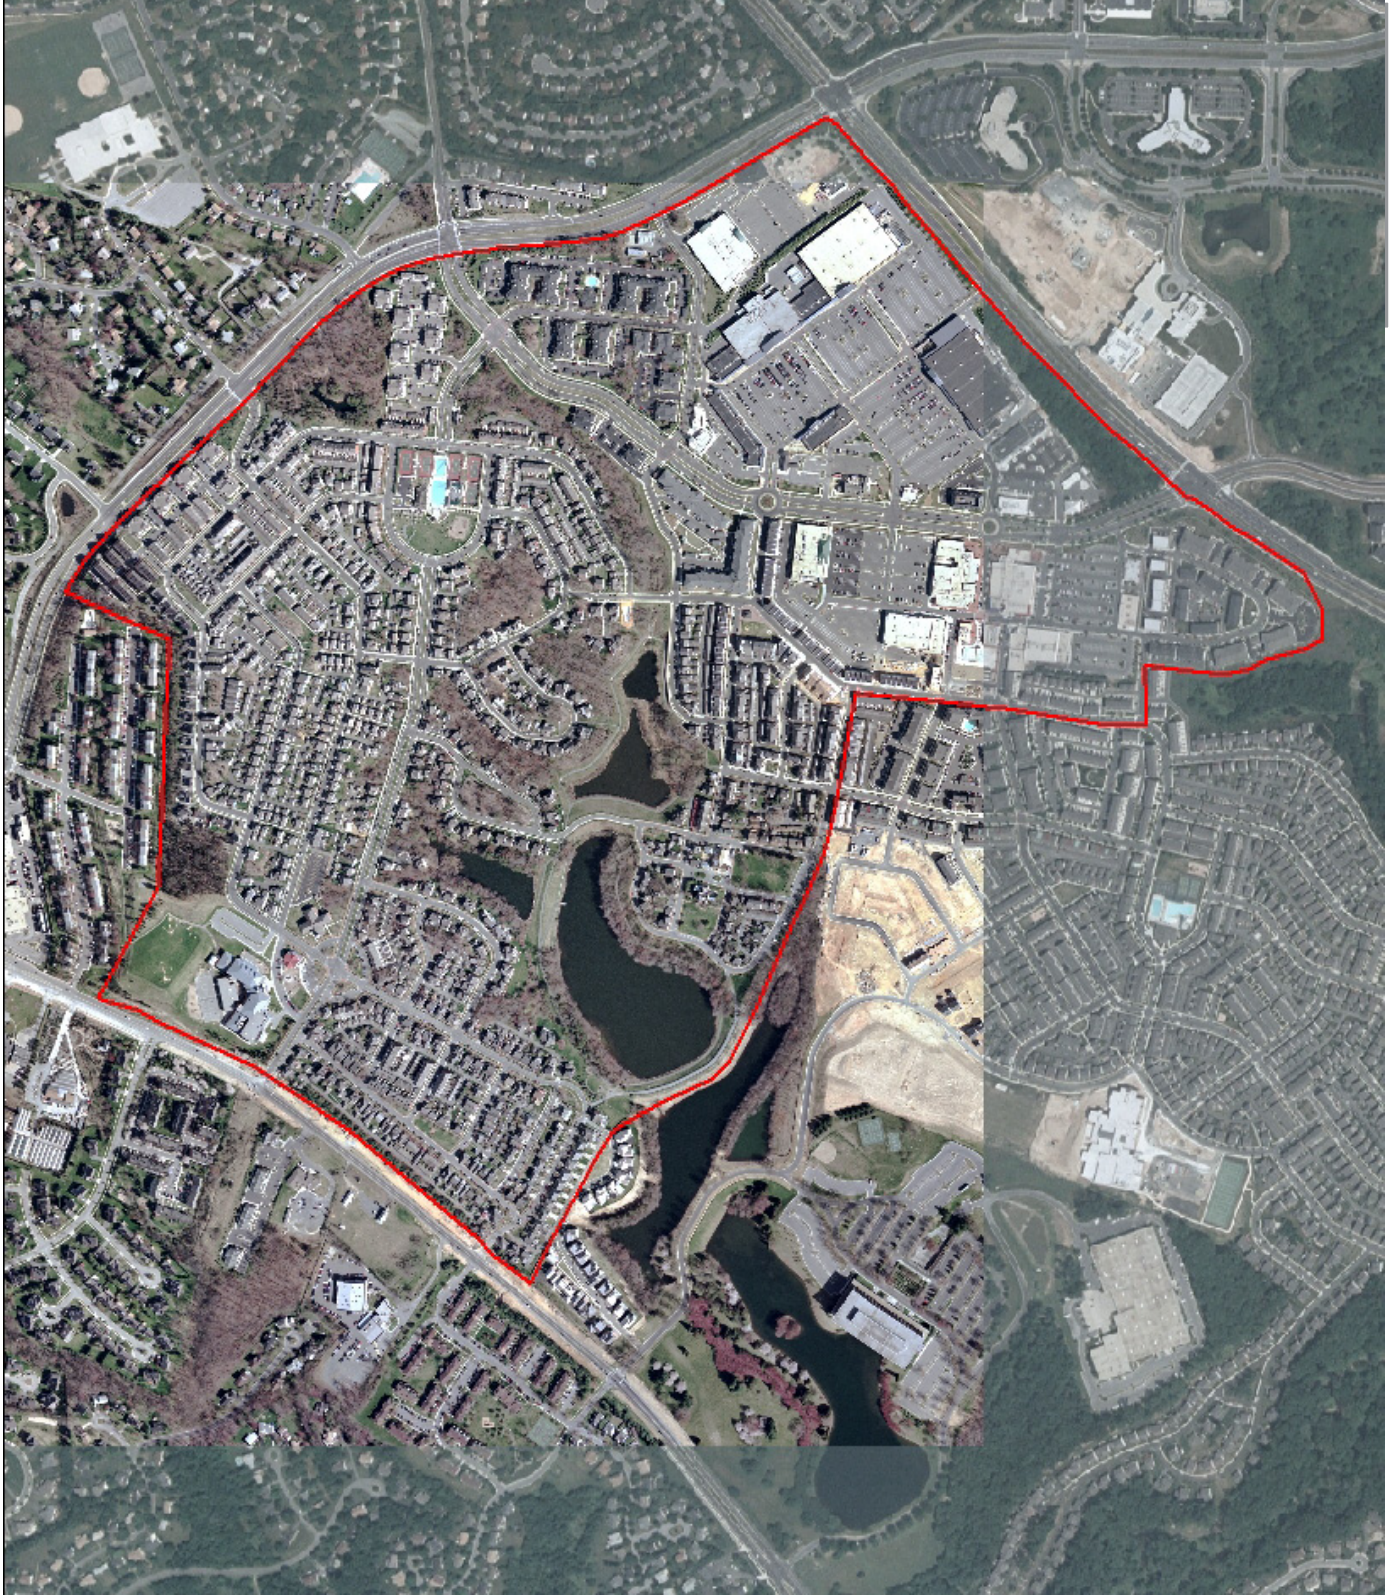
Figure 3: Kentlands in 2005 is fully constructed. The accompanying development of Lakelands, located to the southeast is still under construction.

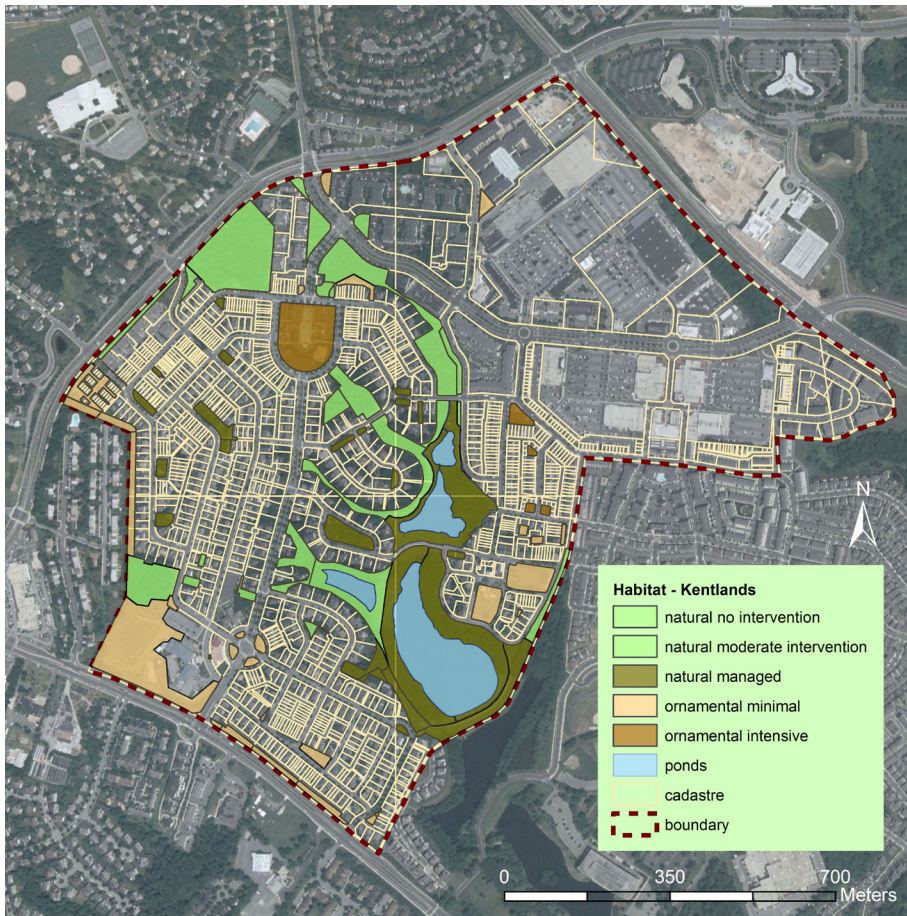
Figure 5: The land cover of the common open space in the development includes natural and ornamental landscapes.

Table 2: Breakdown of the open space vegetation cover by area and percent of total.

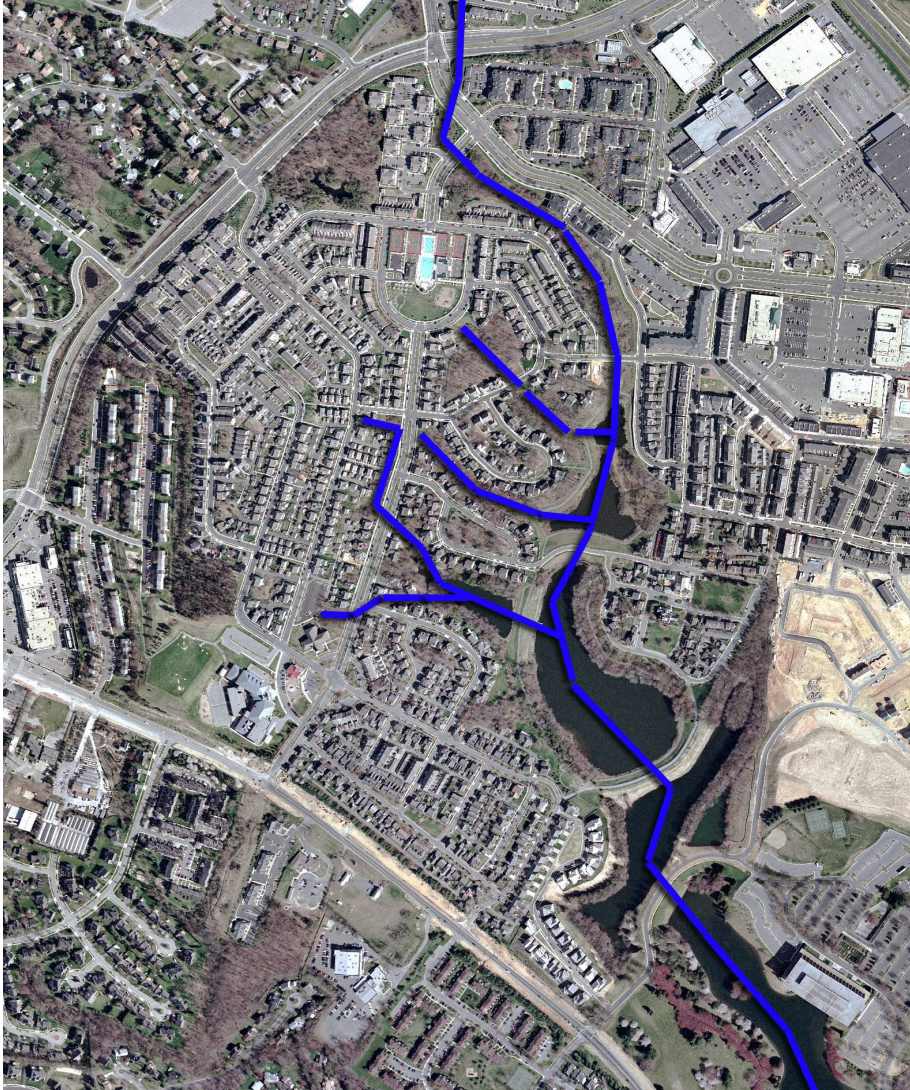
Figure 3: The water flow on site is from the north (top of map) to the south through a series of four ponds, increasing in size as the flow progresses to the south. The ponds pre-date the development, and serve an important stormwater management function before the water enters the Muddy Branch and then the Potomac River.

Table 3: Total imperviousness of the development is high at almost 49%.

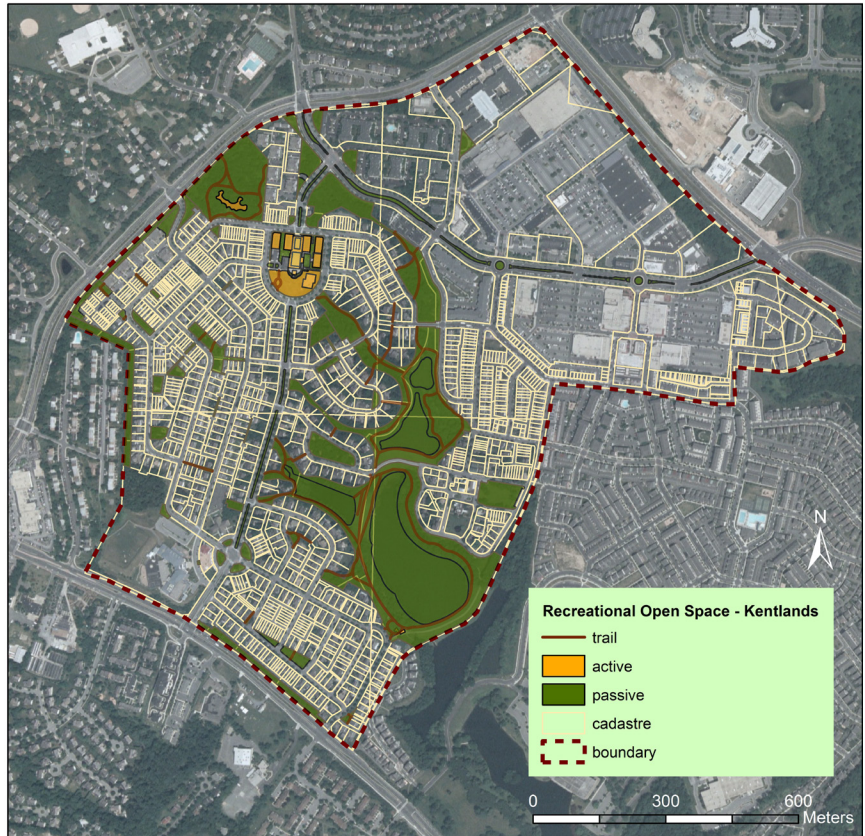
Figure 4: The Kentlands development has an extensive trail network, and a considerable amount of passive open space centered around the ponds system.

Table 4: Characteristics of the open space, showing over 17 percent of the development serving as passive open space and almost 5 kilometers of trails.
